## Raptor Electrocutions and Distribution Pole Types

Prepared by: Rick Harness

EDM International, Inc.

### Abstract

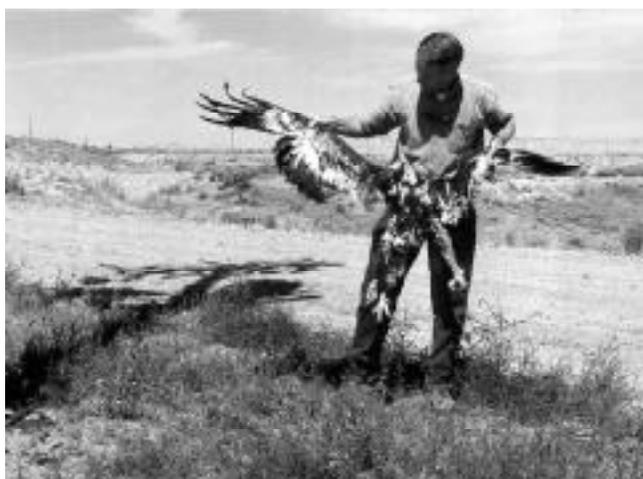
*Photo 1. A juvenile golden eagle electrocuted by a distribution power line.*

Although utility construction practices have improved since 1971, some raptor electrocutions still persist. These electrocutions often cause outages resulting in damaged equipment, safety problems and loss of service to consumers. A 1993 Institute of Electrical and Electronics Engineers, Inc. (IEEE) survey stated the majority of their respondents still experience outages caused by squirrels, birds, raccoons and snakes (IEEE Power Engineering Society 1993). Nationwide, animals are the third leading identifiable cause of all power outages, and birds cause more outages than any other animal (Southern Engineering Company 1996). The United States Department of the Interior investigated 4,300 eagle deaths from the early 1960's to 1995 and reported electrocution as the second greatest cause of all detected golden eagle mortality and the fourth greatest cause of bald eagle deaths (LaRoe et al. 1995) (Photo 1).

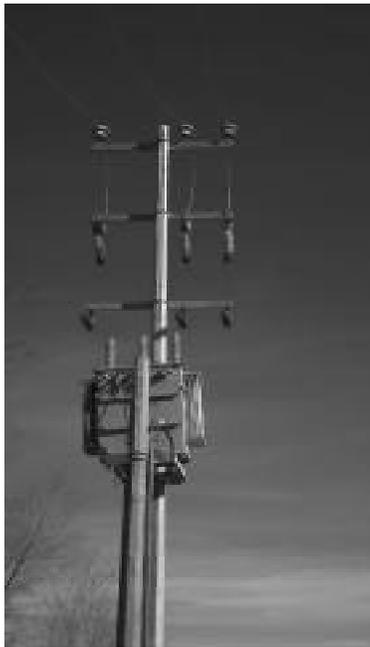
Photo by Cynthia Melcher  
Photo 3. Concrete pole associated with raptor electrocutions in San Pedro, Mexico.

Concrete poles with their internal support structure of metal rebar, pose similar risks to electrocution as steel poles. A 102 mile long concrete pole line constructed with steel crossarms near Janos, Mexico was recently inspected and 49 dead birds were discovered, suspected to be electrocutions (pers. comm. Gail Garber 2000) (Photo 3). Of these 10 were ferruginous hawks, 9 were golden eagles including 5 adults; the rest were a combination of red-tailed hawks, prairie falcons, and one American kestrel.

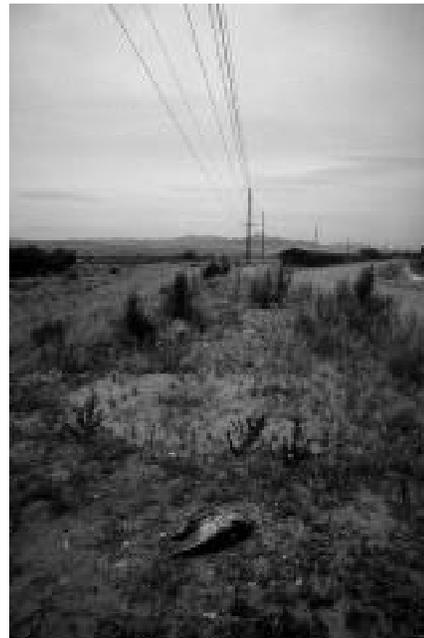
Photo 4. Electrocuted red-tailed hawk under a steel distribution underbuild mounted on a steel transmission pole.

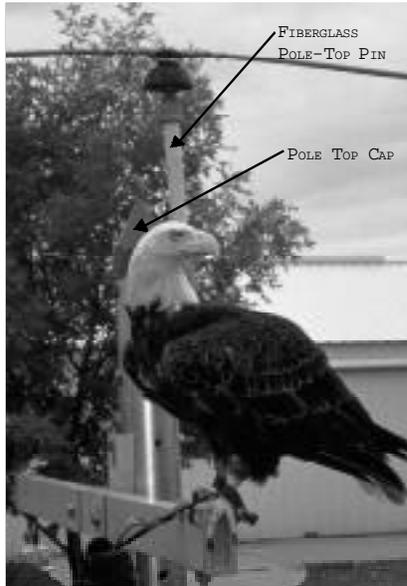
Photo 5. Distribution steel pole fitted with a pole-top cap to exclude perching.

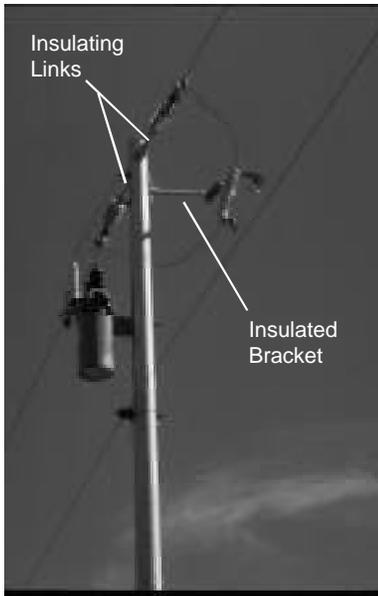
*Photo 6. Steel single-phase double deadend pole with insulating links to achieve 300kV BIL.*

Deadend structures accommodate directional changes and lateral taps. The 300kV BIL level is especially important on deadends where voltage doubling can occur. The 300kV BIL can be attained on steel and concrete poles by installing a 24-inch (minimum length) insulated extension links between the primary deadend suspension insulators and the steel pole (Photo 6). The insulating links cost \$12.75 each. The insulating links are not required to achieve 300kV BIL on wood or fiberglass structures.

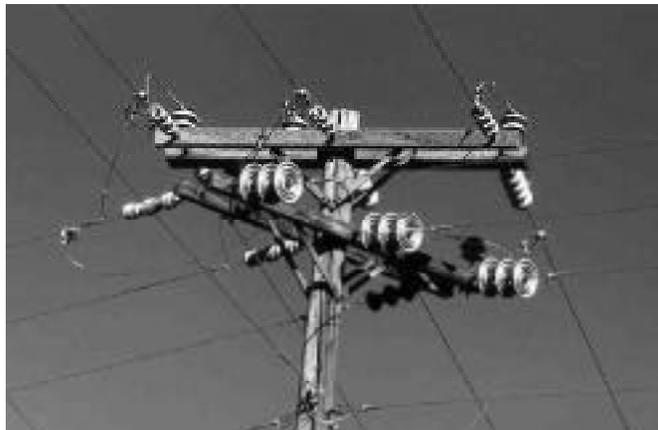
*Photo 7. Deadend structure with inadequate separation between jumper wires.*

Deadend structures can be lethal to animals due to bare jumpering between circuits (Photo 7). Insulating jumper wires is the most common raptor proofing method. On some structures jumper wires can simply be rerouted under crossarms to eliminate potential phase-to-phase contacts. These mitigating measures are typically similar, regardless of pole type.
