Fire Testing of Utility Crossarms

Investigative testing conducted following the test methodology similar to that of proposed ASTM standard for wood poles, but adapted for crossarms

**Brooks Manufacturing
2120 Pacific St.
Bellingham, WA 98229**

WFCi Report #22022r2

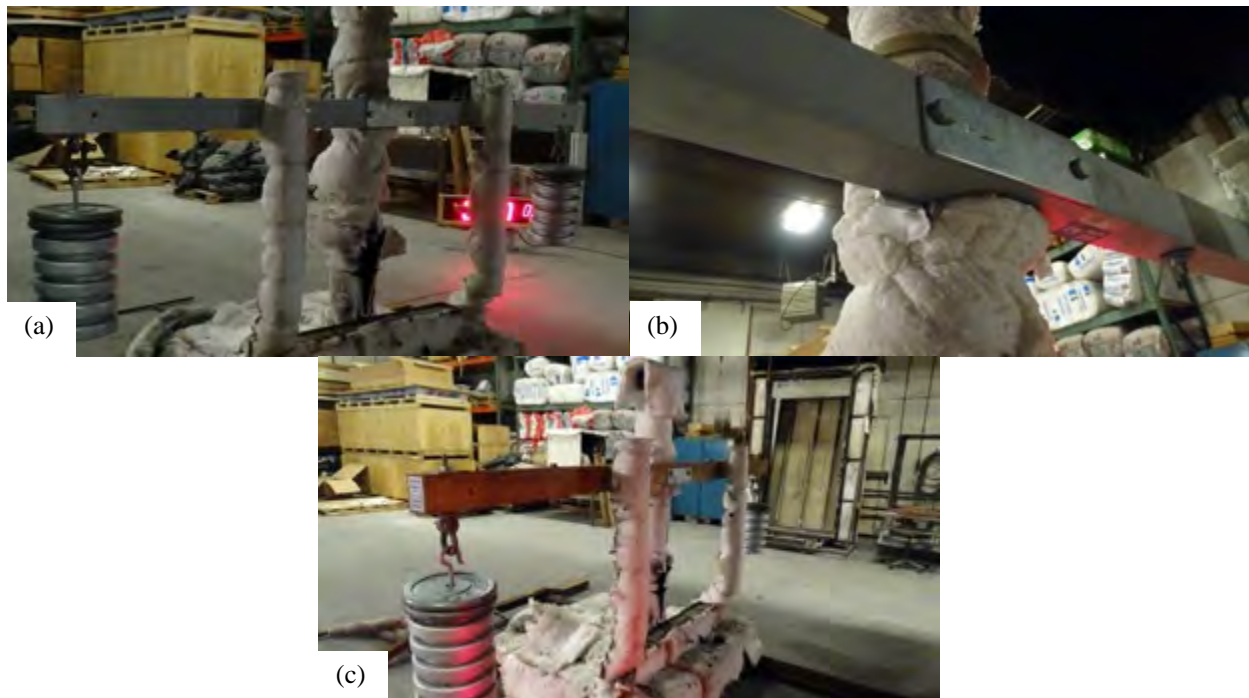
Figure 2. Representative crossarm samples before testing showing (a) Test 1, (b) Test 1 fixture, and (c) Test 2.

Four crossarm samples were tested according to either of the two test methods described above with two different types of arm for each method. Each arm had a specific steel fixture that was bolted to the removeable post, designed for the type of arm. The first arm type was a fiberglass arm (Pupi, 4⁵/₈"×3⁵/₈"×10') with a steel fixture that supported the arm along the face only. The second arm was a treated wood arm (REA 05 FSNP-BBA WQC, 4³/₄"×3⁵/₈"×10') with a steel fixture that supported the arm along both the face and bottom. Specifics for each test type and sample are found below:

- Test 1: Radiant/Burner Combo: Fiberglass Crossarm
- Test 2: Radiant/Burner Combo: Wood Crossarm. 02 22 D.F. 0.13DA
- Test 4: Burner Only: Fiberglass Crossarm
- Test 5: Burner Only: Wood Crossarm. 02 22 DF 0.13DA

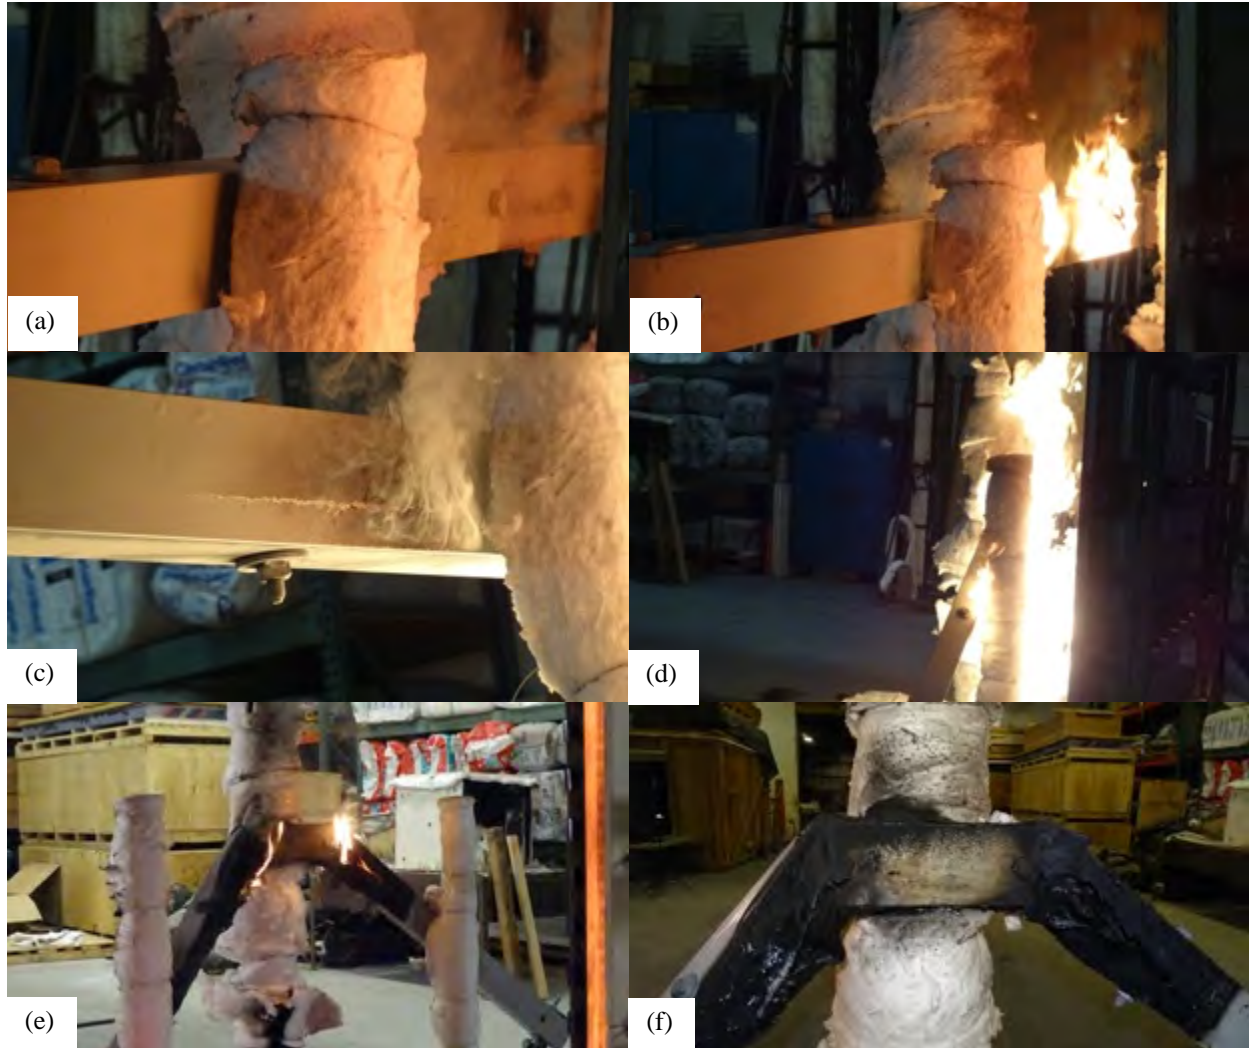
Figure 3. Images during Test 1 showing (a) smoking, (b) ignition, (c) cracking along arm, (d) collapse, (e) continued flames, and (f) after test.

Time (mm:ss)	Event
00:00	Open shield – start test
00:30	Smoking on face
01:20	Darkened face
02:40	Ignition on face
04:00	Flaking of fiberglass material
05:00	Burner on
05:40	Slight movement of crossarm
05:54	Collapse of east side of arm
06:08	Burner off
06:16	Heat shield closed
06:52	Collapse of west side of arm as moving sample away from radiant panel
26:00	Terminate test – slight flames (1” to 2”) at collapsed section of west side of arm Crossarm extinguished with water hose

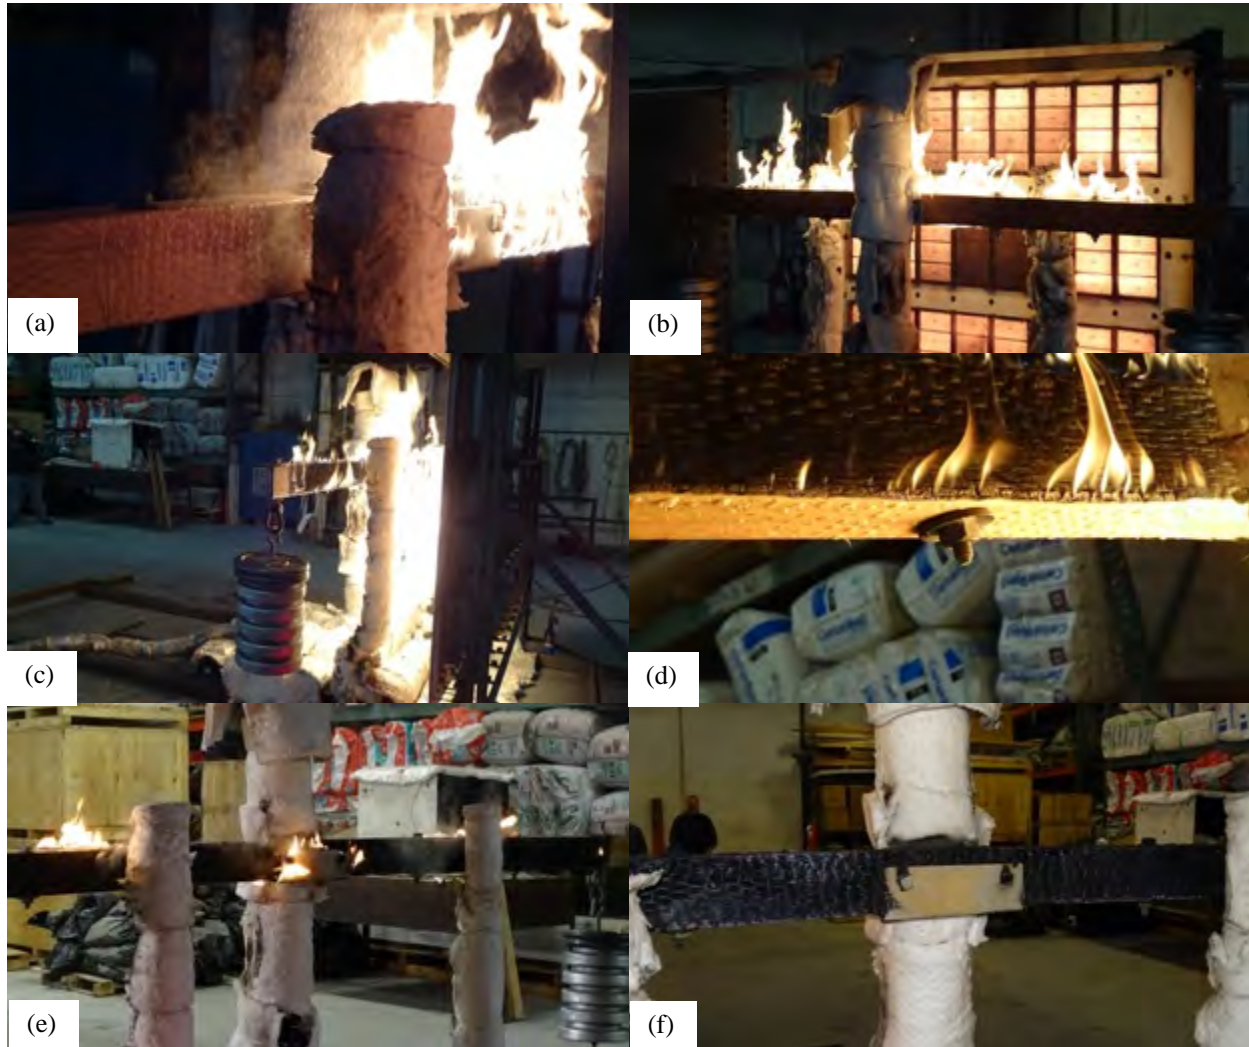
Figure 4. Images during Test 2 showing (a) ignition, (b) flames spreading along arm, (c) burner on, (d) dripping bottom, (e) burners off, and (f) after test.

Time (mm:ss)	Event
00:00	Open shield – start test
00:10	Smoking on face
00:31	Ignition over face
01:15	Flames spread out to east side of guard post
03:00	Dripping liquid from arm

05:00	Burner on
07:00	Dripping liquid forming on bottom of arm
10:00	Burner off – shield closed – continued flames
14:20	Light flames on top of arm
17:00	Flames out (self-extinguished)
20:00	Terminate test – only light smoke remaining

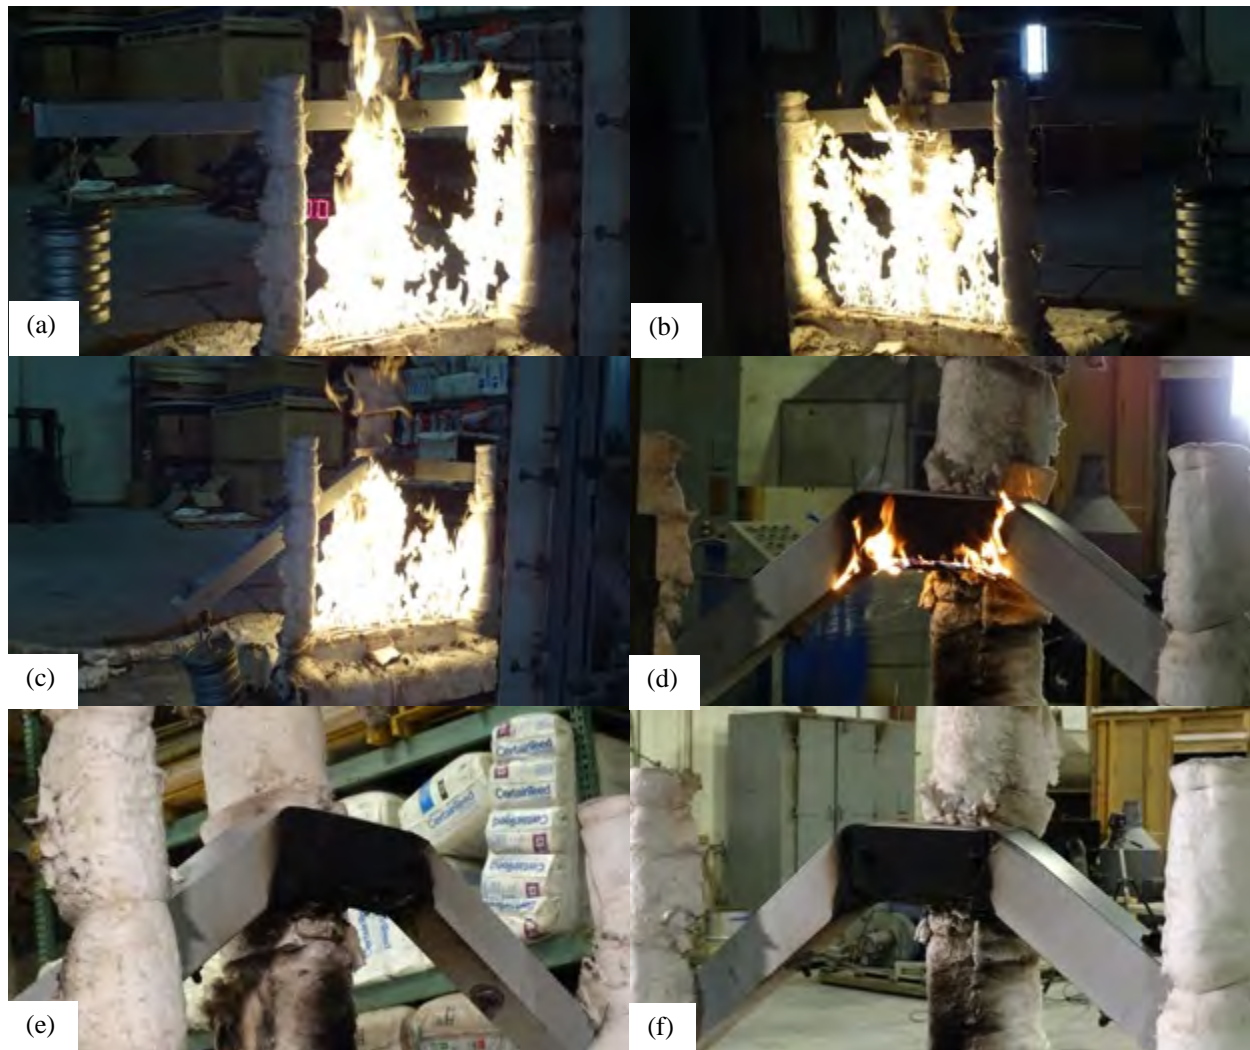
Figure 5. Images during Test 4 showing (a) burner on, (b) attached flames, (c) east collapse, (d) continued flames, (e) flames out, and (f) after test.

Time (mm:ss)	Event
00:00	Burner on
01:22	Attached flames on bottom of arm
04:50	East side of arm drooping
05:10	East side of arm collapsed
07:04	West side of arm collapsed
07:20	Burner off
11:40	Flames out (self-extinguished)
15:00	Terminate test – only light smoke remaining

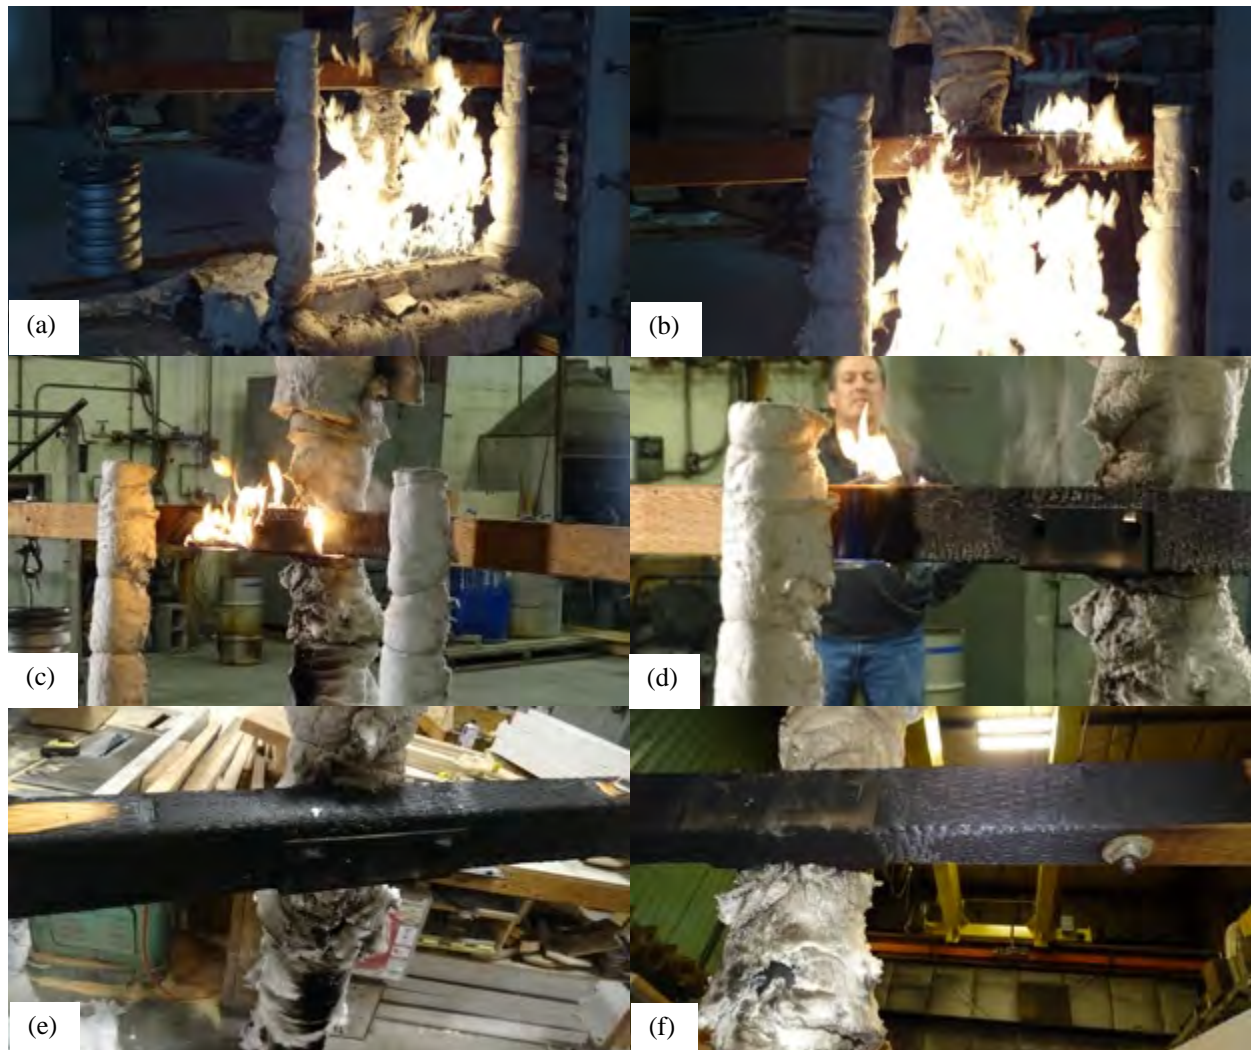
Figure 6. Images during Test 5 showing (a) burner on, (b) attached flames, (c) burner off, (d) continued flames, and (e-f) after test.

Time (mm:ss)	Event
00:00	Burner on
00:45	Attached flames to arm
02:15	Flames on backside of arm
10:00	Burner off – continued flames
12:30	Flames on east side of arm only
22:10	All flames out – continued smoking
23:30	Reignition of flames on east side of arm
30:00	Terminate test – light flames on arm Crossarm extinguished with water hose

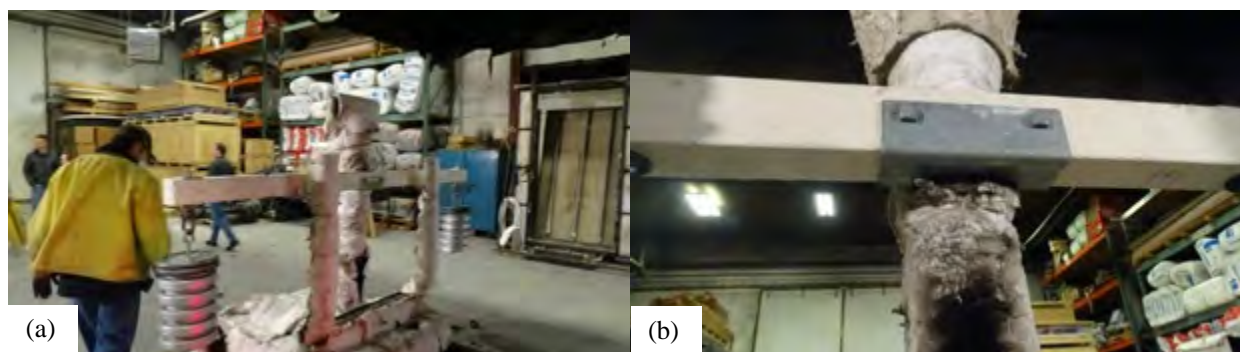
Figure 7. Representative crossarm samples before testing showing (a) Test 3, and (b) Test 6 fixture.

The third arm was a coated wood arm (same base as #2, Flame Off, ~1.15 mm thick) with three brush coats of paint.

- Test 3: Radiant/Burner Combo: Coated Wood Crossarm. 4-22-2022. 1.18 mm. MC 19.06%
- Test 6: Burner Only: Coated Wood Crossarm. 4-21-2022. 1.13 mm. MC 18.3%

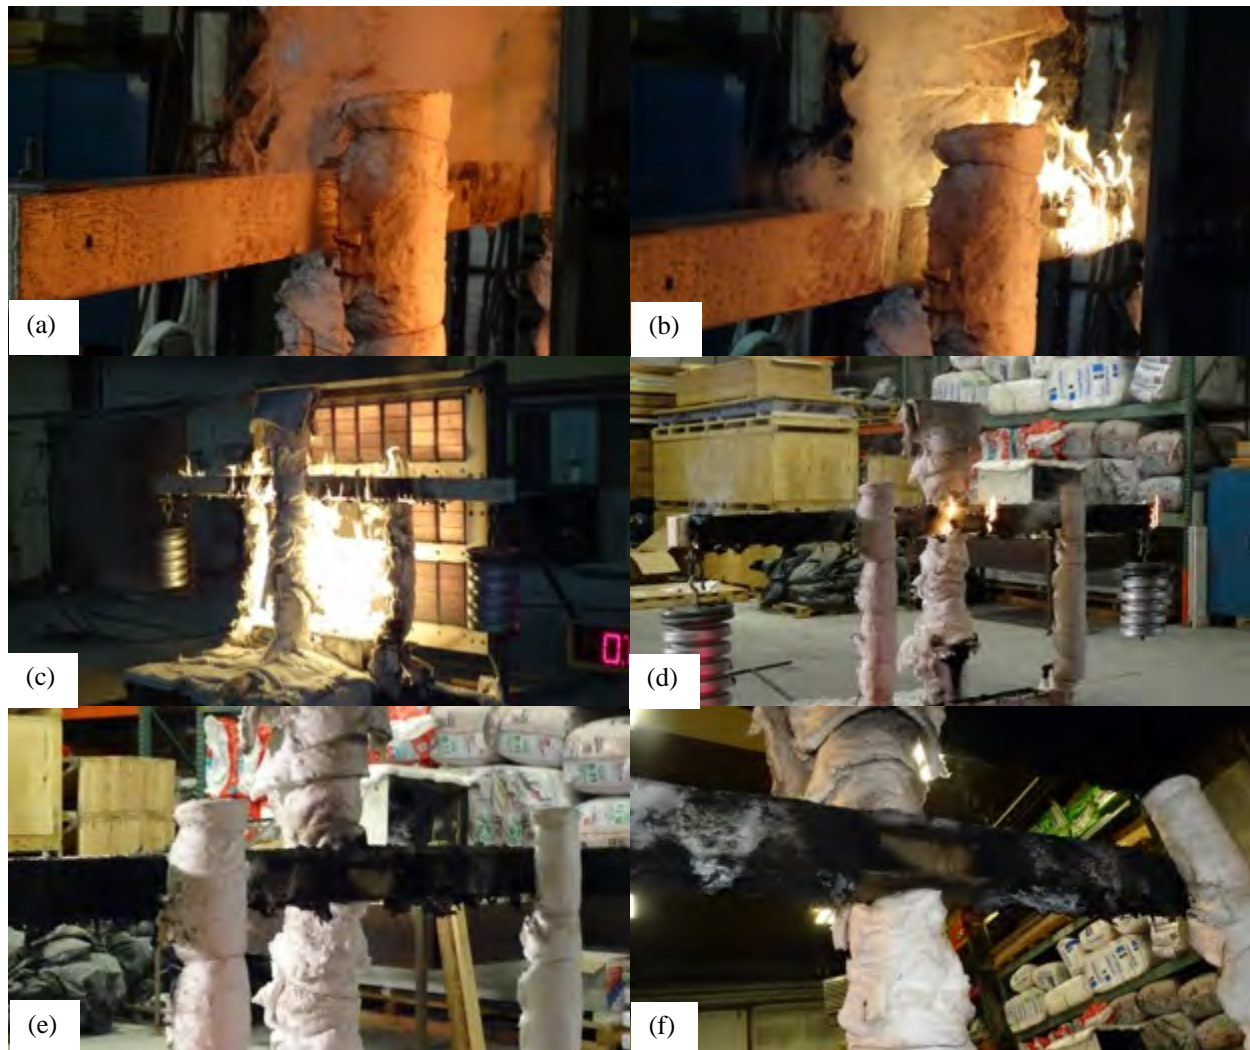
Figure 8. Images during Test 3 showing (a) darkened face, (b) ignition, (c) burner on, (d) burner off, and (e-f) after test.

Time (mm:ss)	Event
00:00	Open shield – start test
00:15	Smoking on face
01:05	Ignition over face
01:40	Dripping material
02:30	Flaking intumescent
03:00	Peeling material from bottom of arm
05:00	Burner on – continued dripping of coating
10:00	Burner off – shield closed – continued flames
14:25	Flames out (self-extinguished)
18:00	Terminate test – only light smoke remaining

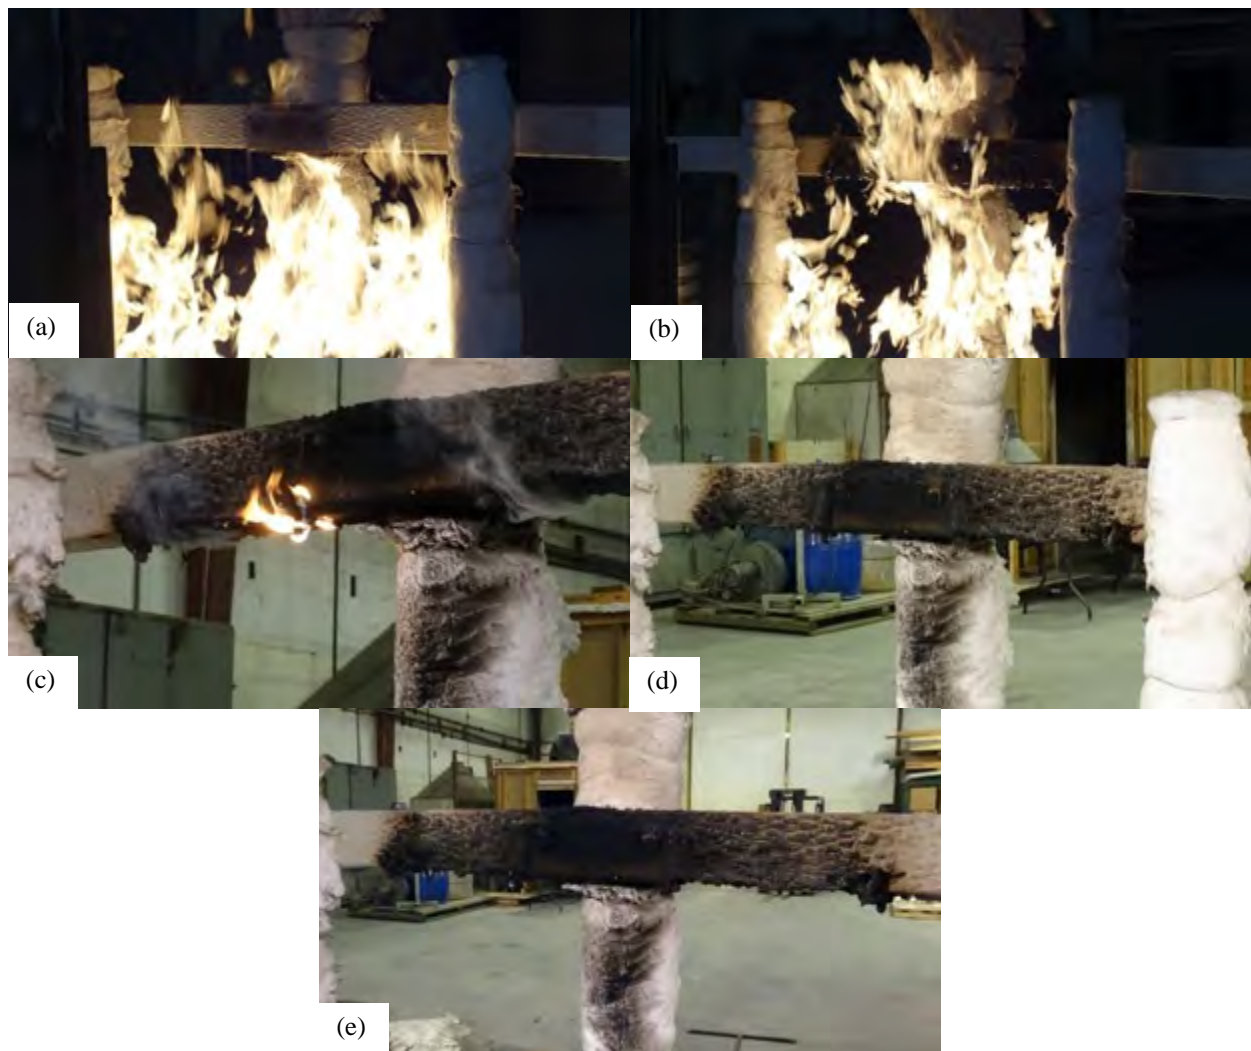
Figure 9. Images during Test 6 showing (a) bubbling, (b) attached flames, (c) burner off, (d) flames out, and (e) after test.

Time (mm:ss)	Event
00:00	Burner on
00:30	Bubbling coating
02:20	Fallen coating from bottom of arm
02:30	Ignition of arm
10:00	Burner off – continued flames

13:00	Flames out (self-extinguished)
18:00	Terminate test
